IN THE MIDST OF A LONELINESS

THE ARCHITECTURAL HISTORY OF THE SALINAS MISSIONS

Salinas Pueblo Missions National Monument Historic Structure Report

Professional Papers No. 15

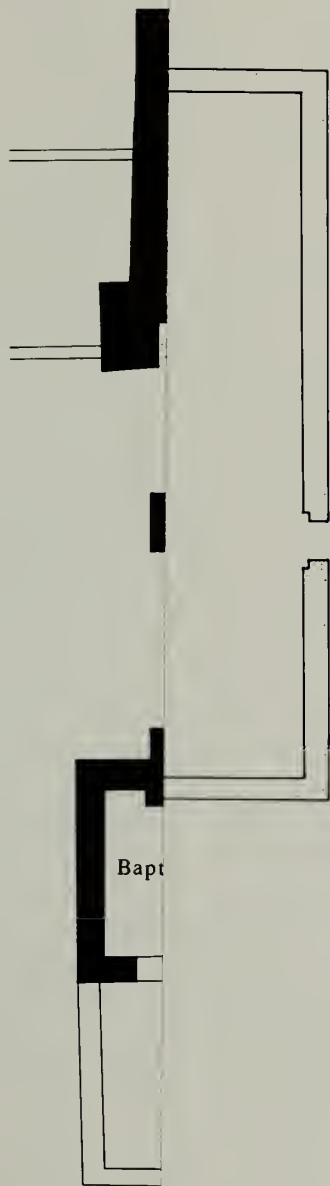
Figure 4. The plan of the mission of Abó after its first reconstruction. The church was almost doubled in size, and a new, larger sacristy added. The patio was changed to accomodate the new sacristy storeroom on the west. The kiva was probably filled to a depth of about 6 feet as part of this reconstruction. The portería and front platform are again conjectural, based on their appearance after several reconstructions.

¹⁸It would have been impossible for Acevedo to carry out the rebuilding of San Gregorio de Abó without an elevation drawing of both the first church of Abó and of the planned second church. For example, the plan of the addition to Abó included a bell-tower in the southwest corner of the new transept-like addition. The plan was specifically laid out with a thickened wall and a corner buttress here, unlike the equivalent corner on the opposite "transept," which was braced by a concealed corner buttress in the form of a wall segment seven feet thick and twelve feet wide. The additional thickness of wall planned for the west side of the nave required that a fifteen-foot segment of the west nave wall had to be removed, while on the east wall only the area of the north corner itself was removed. The buttress and wall-thickening on the west side had no other purpose but to support the bell tower. This demonstrates that the bell tower platform and the method by which it was supported was planned before the walls of the first church were ever dismantled.

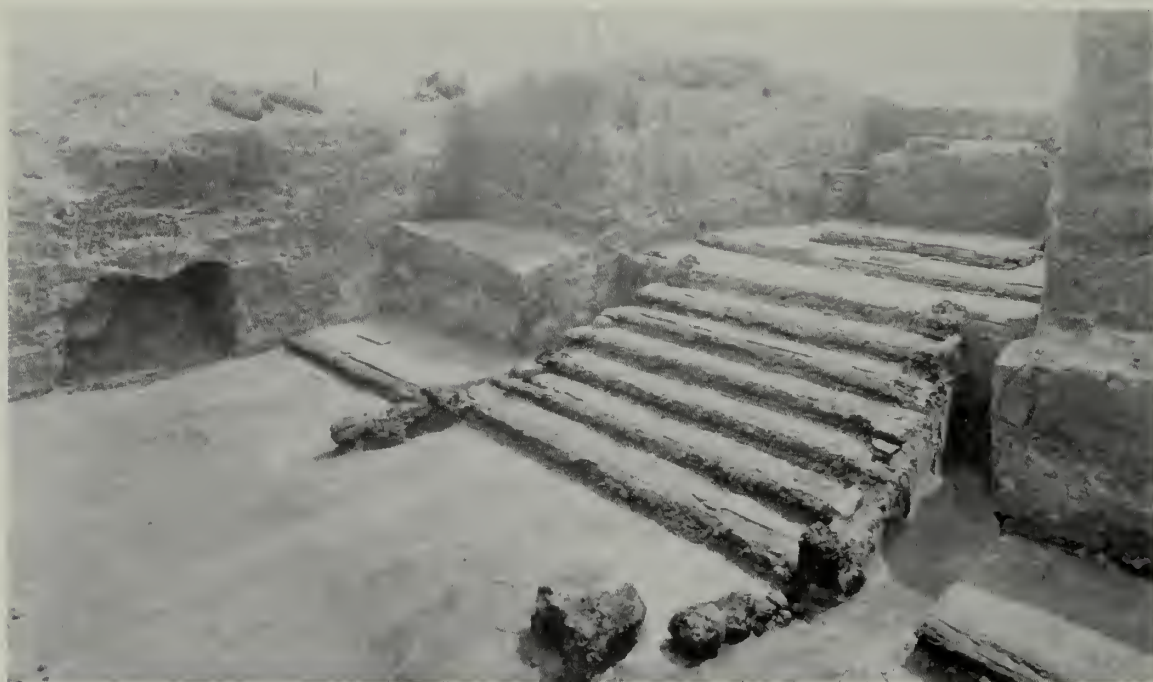
Figure 5. The sanctuary area and altars of the church at Hawikuh, burned out in 1672. The altars of Abó and Quarai probably looked very much like this. At the left and right front corners of the stairs up to the main altar can be seen the fallen remains of the large post that supported the bannister for the stairs. The predella platform under the main altar is visible, as are the platforms for the side altars.

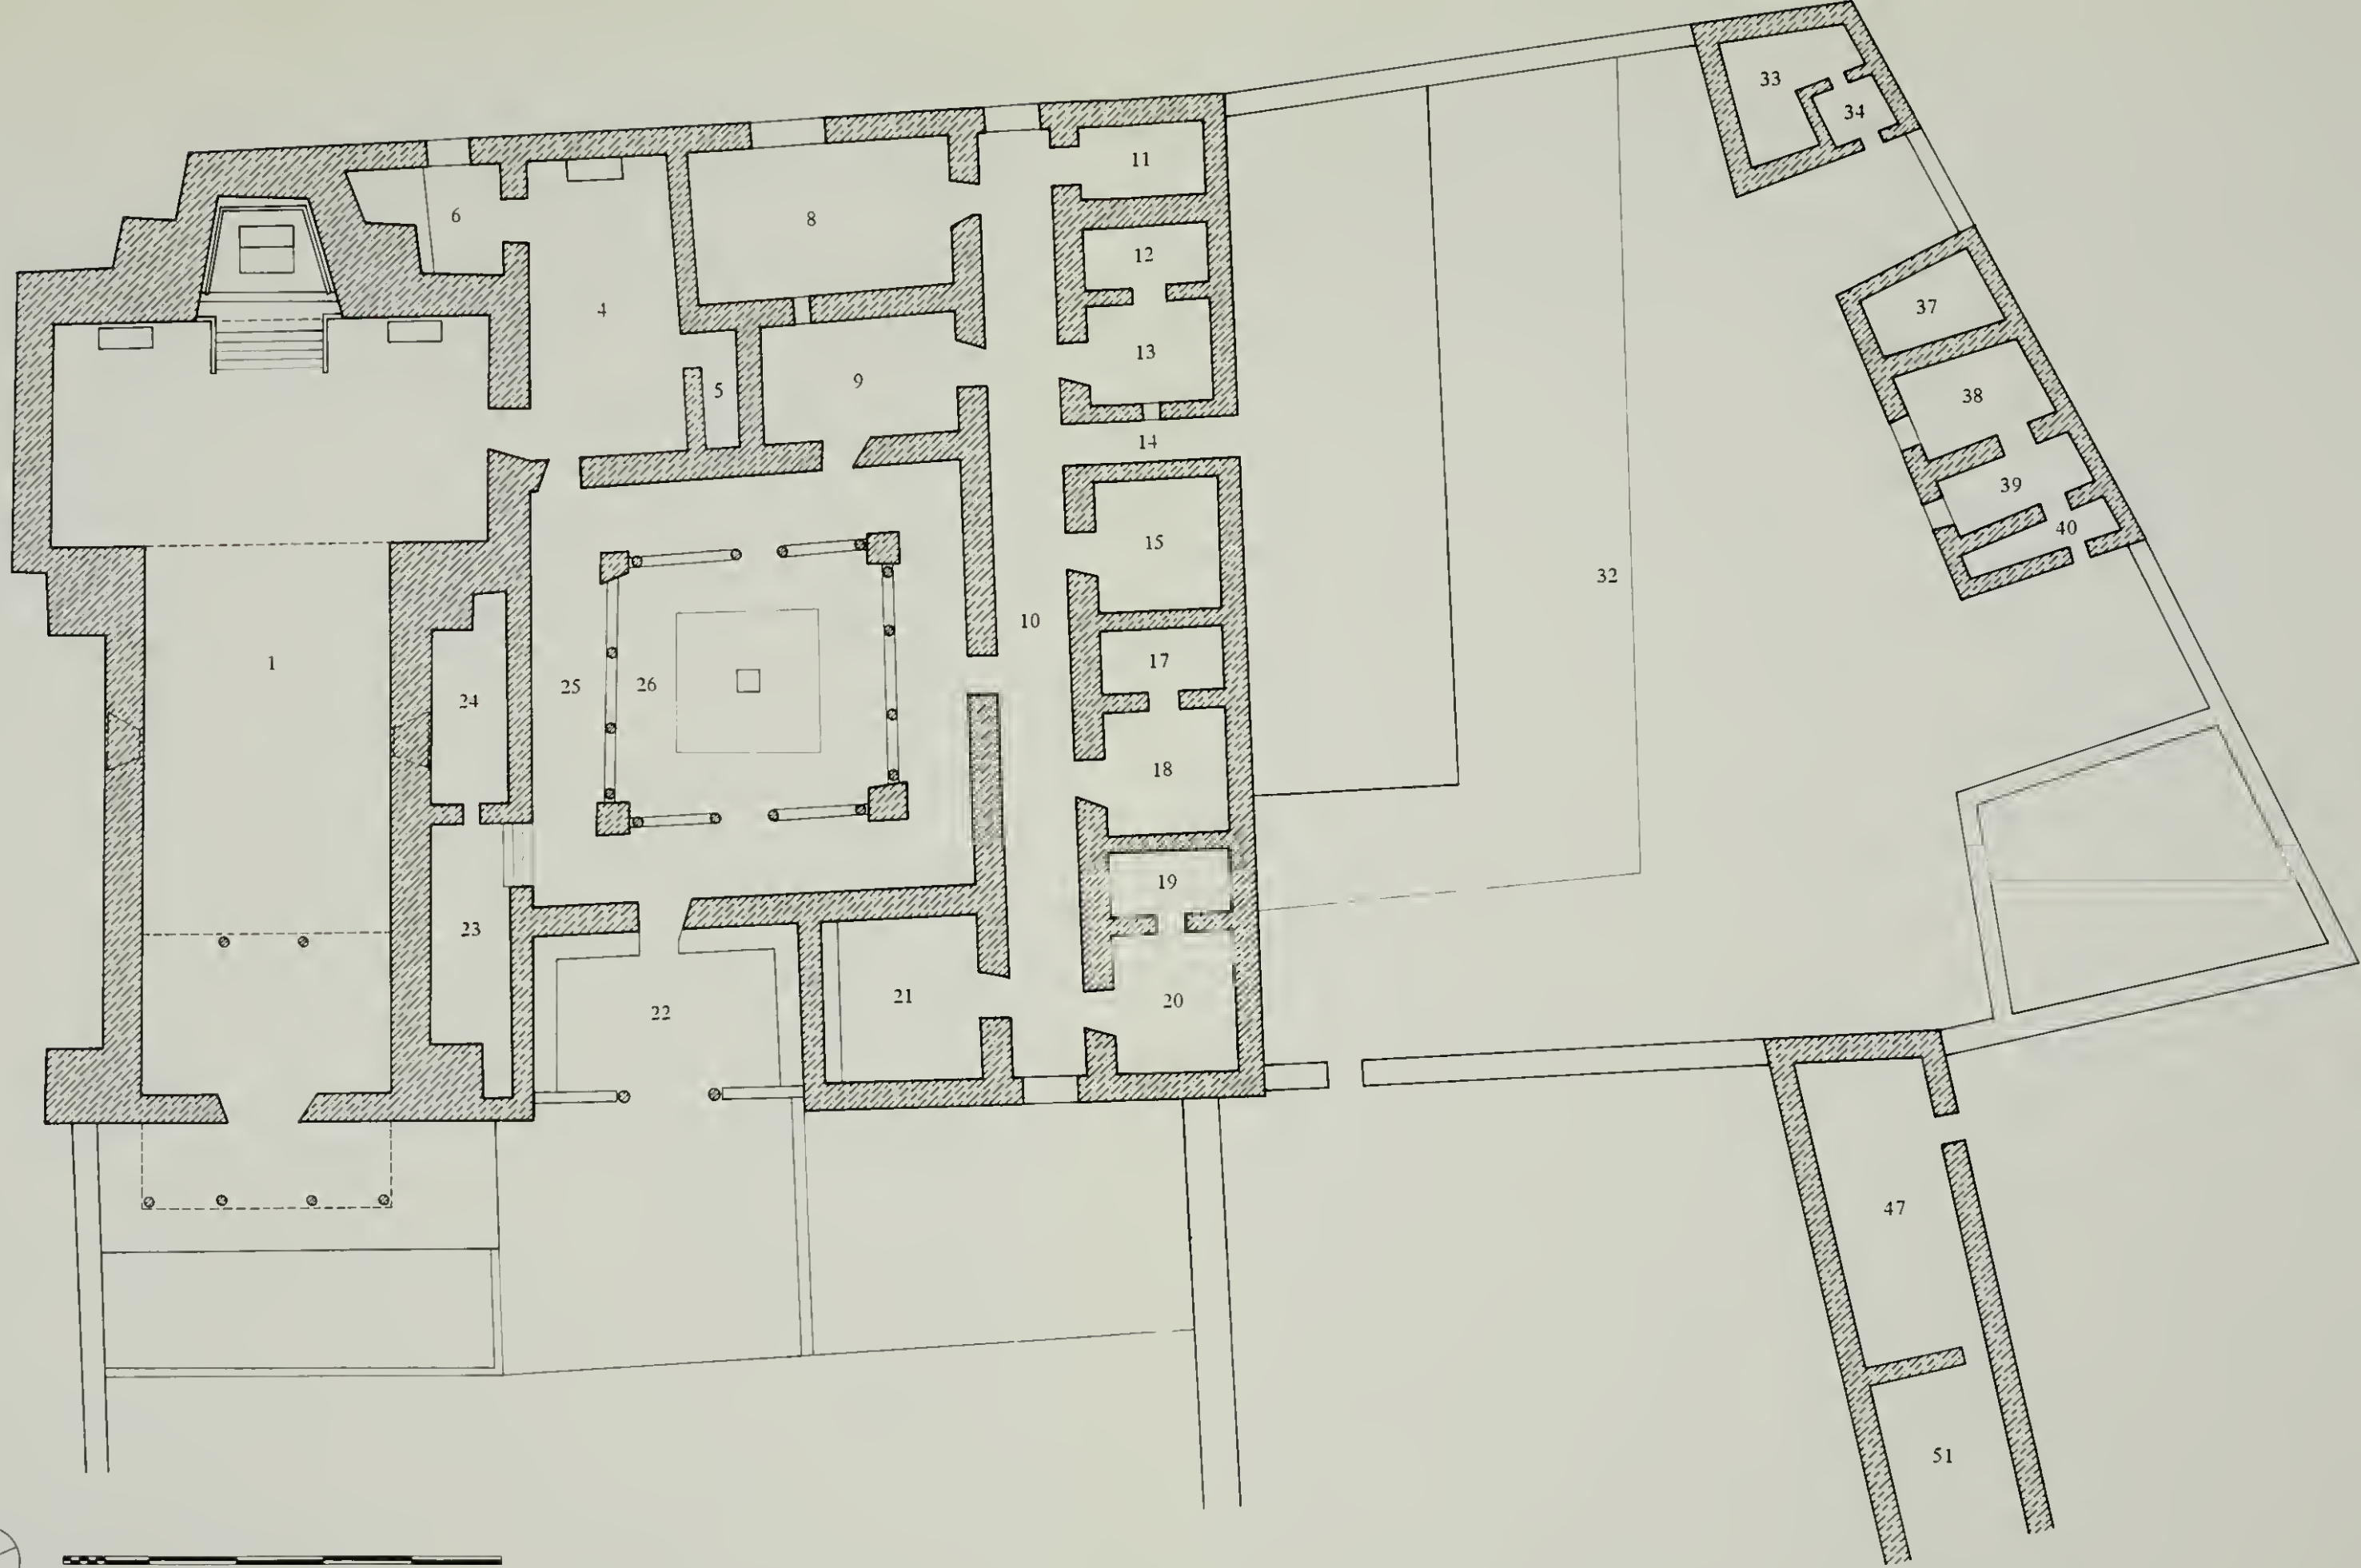
Figure 13. The mission of Nuestra Señora de Purísima Concepción de Quarai. This plan shows the original plan of the church and main convento as completed about 1632. The patio portal is supported on masonry piers at the corners and wooden pillars between. The portería portal is the same. The baptistry has not yet been built, and the west nave window is still open.

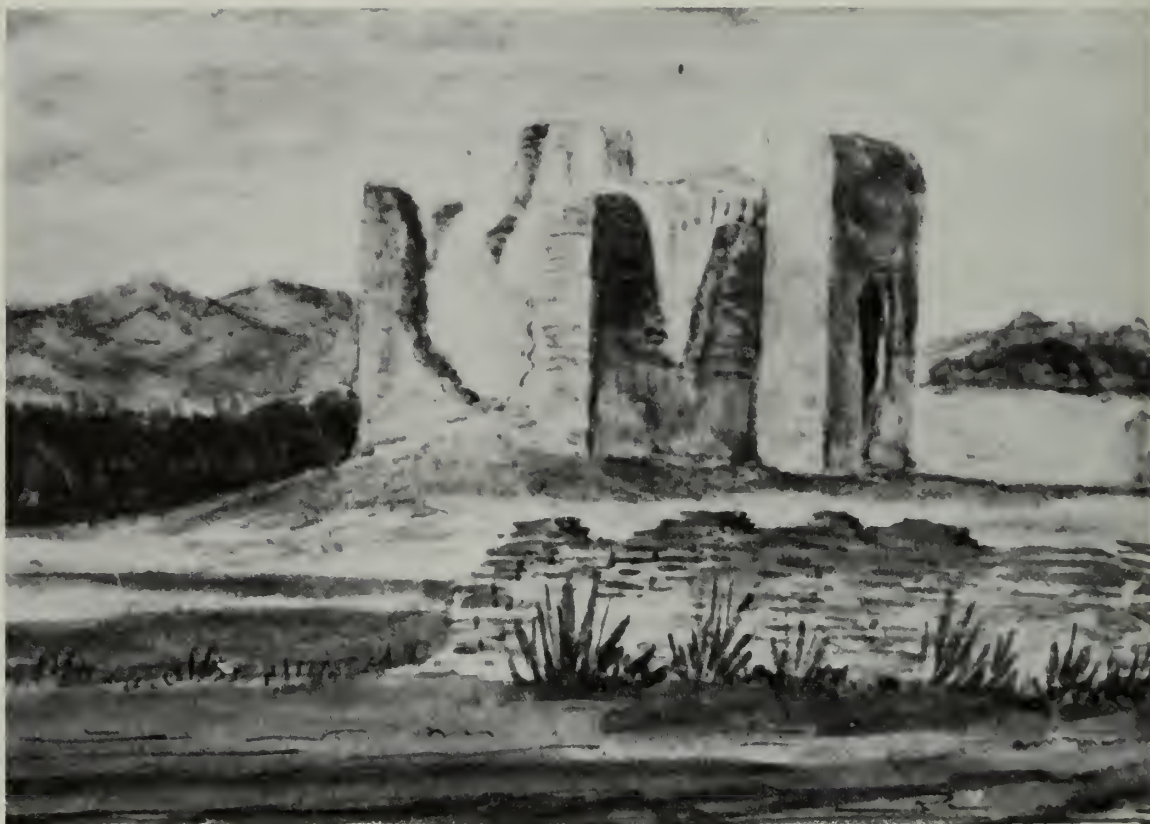
Figure 24. Abó as painted by Abert in 1846. The painting documents a number of critical details about the church and its surroundings. No traces of the front porch are visible, and the lintels of the front entrance and choir loft window are both gone, probably destroyed in the fire that gutted the building in perhaps 1830. The deep notch on the east (right) side marks the location of the window at the mid-point of the nave, while the choir loft doorway does not seem to be visible at all. The second-story doorway that once opened from the roof of the sacristy into the east side-chapel has fallen out above the location of the lintel, but the collapse has not penetrated all the way up to the parapet. On the west (left) side of the nave, the high point marks the location of the buttress outside the wall, while the drop-off to its left probably indicates the location of the notch where the masonry has fallen above the sacristy doorway. Beam sockets can be identified on the north wall of the church. In the original watercolor, differences in shading indicate that Abert could see five sockets in the north wall of the sanctuary, and the first two sockets of the beams over the apse. These two sets of sockets are at about the same height, indicating that the ceiling of the apse was almost as high as the ceiling of the sanctuary. To the right of the church, the walls of the sacristy still stand to about their full height. The ruined wall in the foreground and a poorly-defined wall extending across the background to the right of the sacristy, below the trees, all appear to be ruins of the ca. 1810 to ca. 1830 reoccupation of the area. The interior of the church still clearly shows extensive traces of the white plaster that once covered it.

⁴¹The height and arrangement of the apse vigas can be seen in Lieutenant J. W. Abert's watercolor, figure 24. Abert depicted two of the viga and corbel sockets of the apse. This is fortunate, because the apse and the entire north wall of the church above the altars collapsed between November, 1846, and Bandelier's photograph taken in December, 1882. In 1846 Abó was in about the same condition as Quarai seventy years later, in the 1910s.

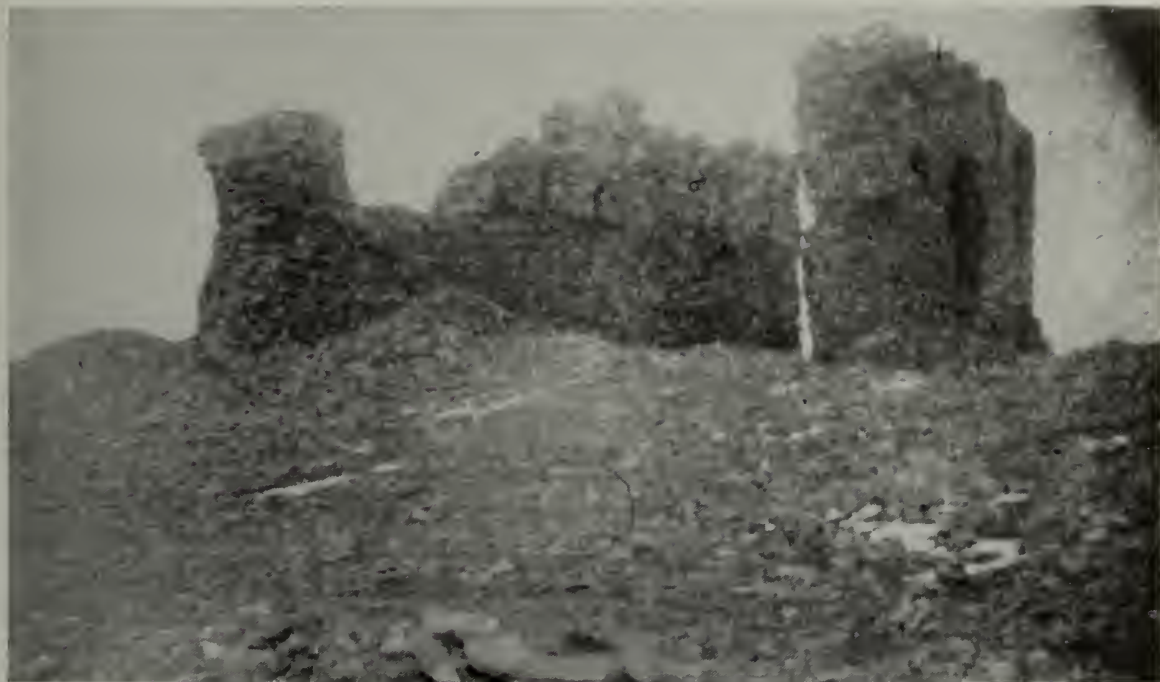
Figure 25. Abó in 1882 as photographed by Bandelier. This picture was taken from almost the same angle as Abert painted his watercolor 36 years before. Since Abert's watercolor, large sections of the walls of the church have fallen. The southwest tower and the south end of the west wall of the nave have fallen, as well as the east wall of the nave from the southeast tower to the east side chapel. The southeast tower itself still stands. At the north end of the church, the entire apse wall of the building has fallen. The crenelations along the tops of the walls can easily be seen. Biblioteca Apostólica Vaticana, Archivo Fotografico, # 482-47, courtesy Charles Lang.

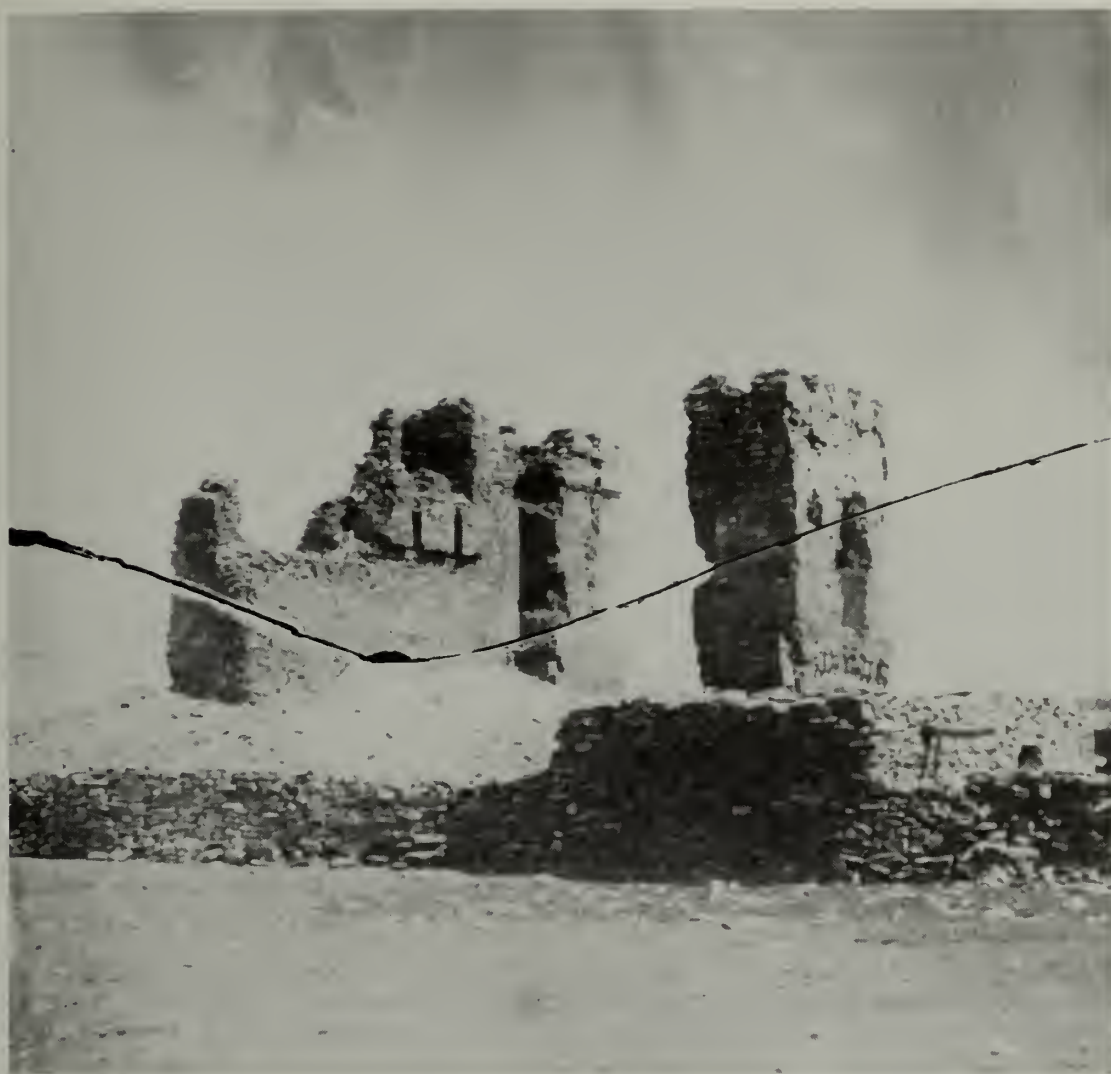
Figure 26. Abó as seen by Charles Lummis in 1890. This picture was made from almost the same angle as the Bandelier photograph 8 years earlier. In the interval the southeast tower had finally collapsed, but few other changes can be seen. In the foreground, walls and structures constructed during the second reoccupation after 1860 are visible. Bandelier's photograph was taken somewhat closer to the church, so that these walls and structures were behind him, out of the picture. Courtesy Southwest Museum, # 24832.

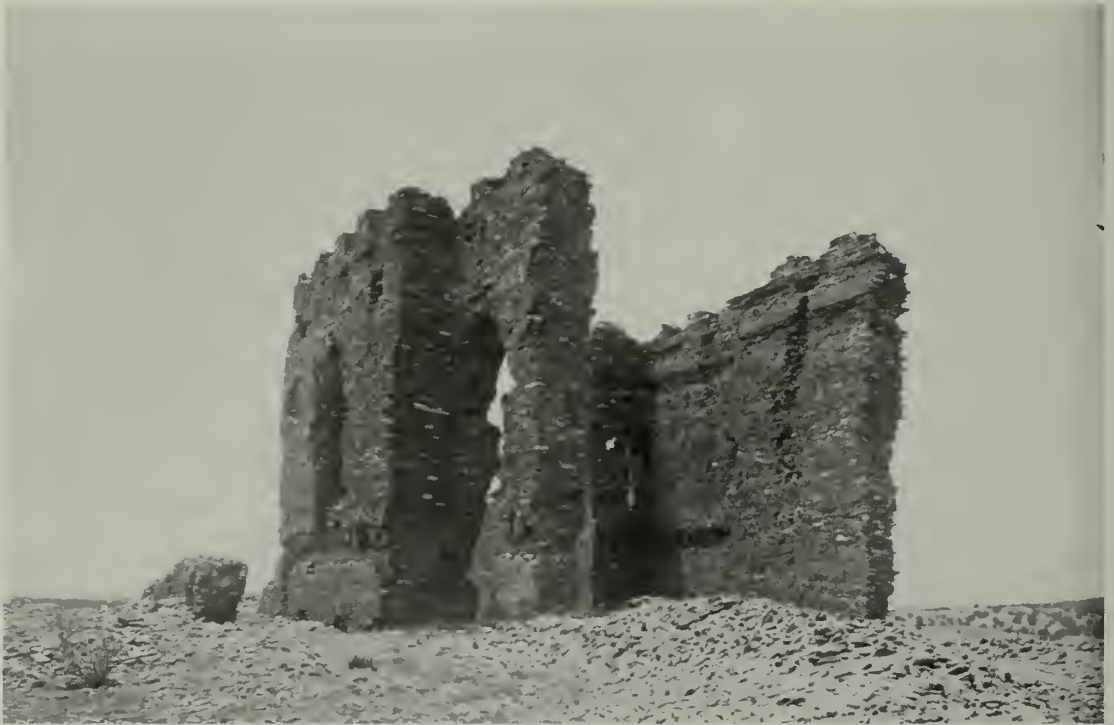
Figure 27. A second view of Abó in 1890. This picture is looking towards the southwest, and the north or sanctuary end of the church is in the foreground. In both this and the previous picture, the crenelations at the top of the building can be seen clearly. These two Lummis photographs are critical to the analysis of the structure of Abó, because only they record several items of important information. The wall at the right in this picture is the west wall of the sanctuary (or transept in the case of Abó, with its peculiar arrangement of space. At the top of the wall, below the crenelations, can be seen two horizontal bands in the stonework. The upper of these is the scar left by the roofing above the roof vigas themselves, which in this area ran lengthwise down the church, or parallel with this wall. The lower horizontal band marks the sockets of the bond beams creating the box-like structure around the wall tops of the high walls of Abó. The bare wall between the two bands was covered by the westernmost of the roof vigas in this area. The vertical, irregular scar down the face of the wall was produced by a failed roof canal. Instead of draining roof water through the wall, the canal became blocked, the water pooled, the roof seal failed, and water began running down the inner face of the wall, cutting this channel. This indicates that the roof sloped down towards this wall. In this and the previous photograph, three sockets can be seen in the irregular scarring left by the leak. They line up with three sockets a few feet to the south at the corner of the side chapel. The six sockets together are the last traces of the central support for the high roof of the church as well as the catwalk from balcony to balcony. The sockets for the floor of the west balcony are visible below and to the left. On the left, or east, side of the church, the second window into the sanctuary can be seen above the remnants of the sacristy doorway. To the left of the sanctuary window is the large doorway that once opened from the sacristy roof onto the east balcony inside the church. The beam sockets and bond beam sockets for the sacristy roof are visible below this door and the sanctuary window. Courtesy Southwest Museum, # 24831.

⁴⁰That the high roof drained to the west is demonstrated by two Lummis photographs showing a water-erosion scar on the inner face of the west sanctuary wall. This mark is the sort left when a canal becomes blocked and water collecting at its mouth leaks through the roof, making a larger and larger hole. The scar could only be formed when the roof was still in place, and must have occurred in the period after church maintenance ended but before the roof burned. See MNM # 24831 and 24832 (Lummis, 1890), reproduced in figures 26 and 27.

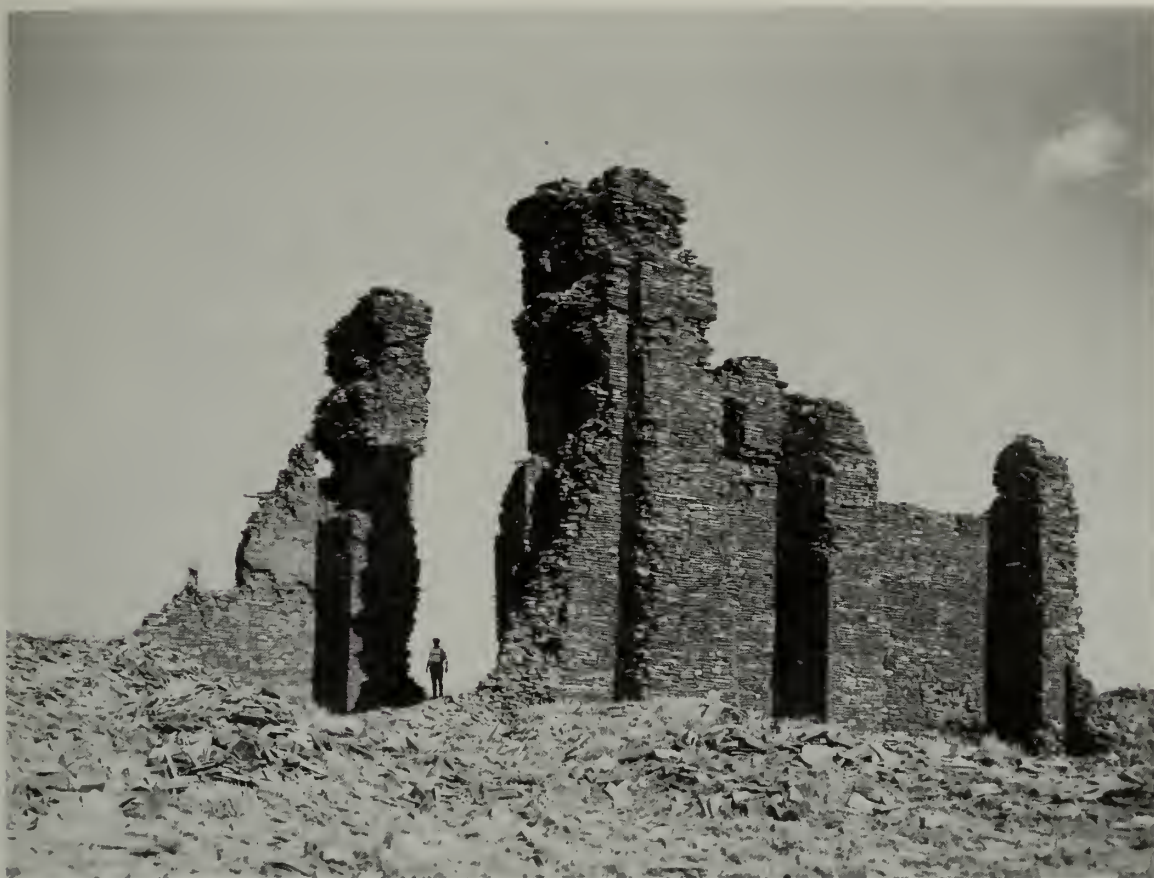
Figure 28. Abó from the northwest in 1916, by Jesse L. Nusbaum. The walls of the sanctuary and side chapels have fallen, except for the buttressed area of the bell tower, and the tower buttress on the east side. The southernmost bottom corner of the balcony doorway is visible just to the right of the figure sitting on the sill of the doorway on the wall. Below the doorway can be seen the irregular traces of the sockets for the eastern balcony. On the shadowed north face of the east tower buttress, the dark patches of the socket for the viga that supported the balcony can be seen, with the sockets of the balcony railing above it. The large depression in the wall above the railing sockets is the socket for the east end of the lower clerestory vigas and corbels; the hole through the wall at this point marks the end of the vigas themselves where they penetrated to within inches of the outer surface of the wall. Several feet above this is the smaller indentation of the upper clerestory viga socket, and in the irregular wall surface above this and below the crenelations are the sockets of the vigas and corbels for the high roof above the clerestory. A similar series of sockets can be seen in the bell tower section of the west wall, closer to the camera. Courtesy Museum of New Mexico, # 12876.

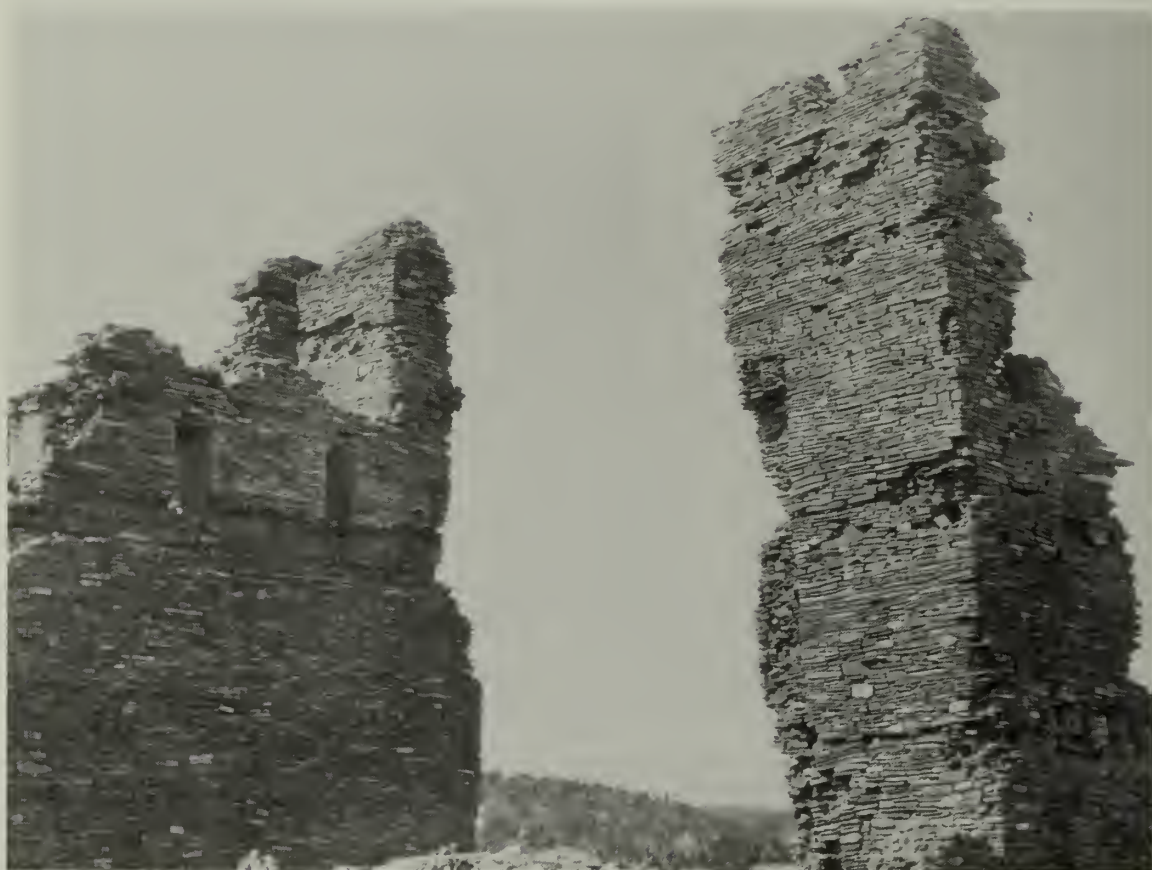
Figure 29. Abó in about 1916. This is a closeup of the southeast corner of the east side chapel and the east face of the west wall of the nave, taken by an unknown photographer. Fine details such as the second level of inset of the crenelations and the imprints of both bond beams on the west wall can be seen. The scar of the east wall of the nave is visible on the east buttress tower, and the corbel sockets, viga sockets, and the scar of the small section of wall that had been at the edge of the doorway from the sacristy to the corridor can all be seen in this view. To the left of the rectangular sockets of the sacristy roof, the smaller round sockets of two corridor roof-beams are visible, and next to them on the south face of the tower, the irregular horizontal shadow line in the stonework marks the upper surface of the roof of room 18. Courtesy Museum of New Mexico, # 58308.

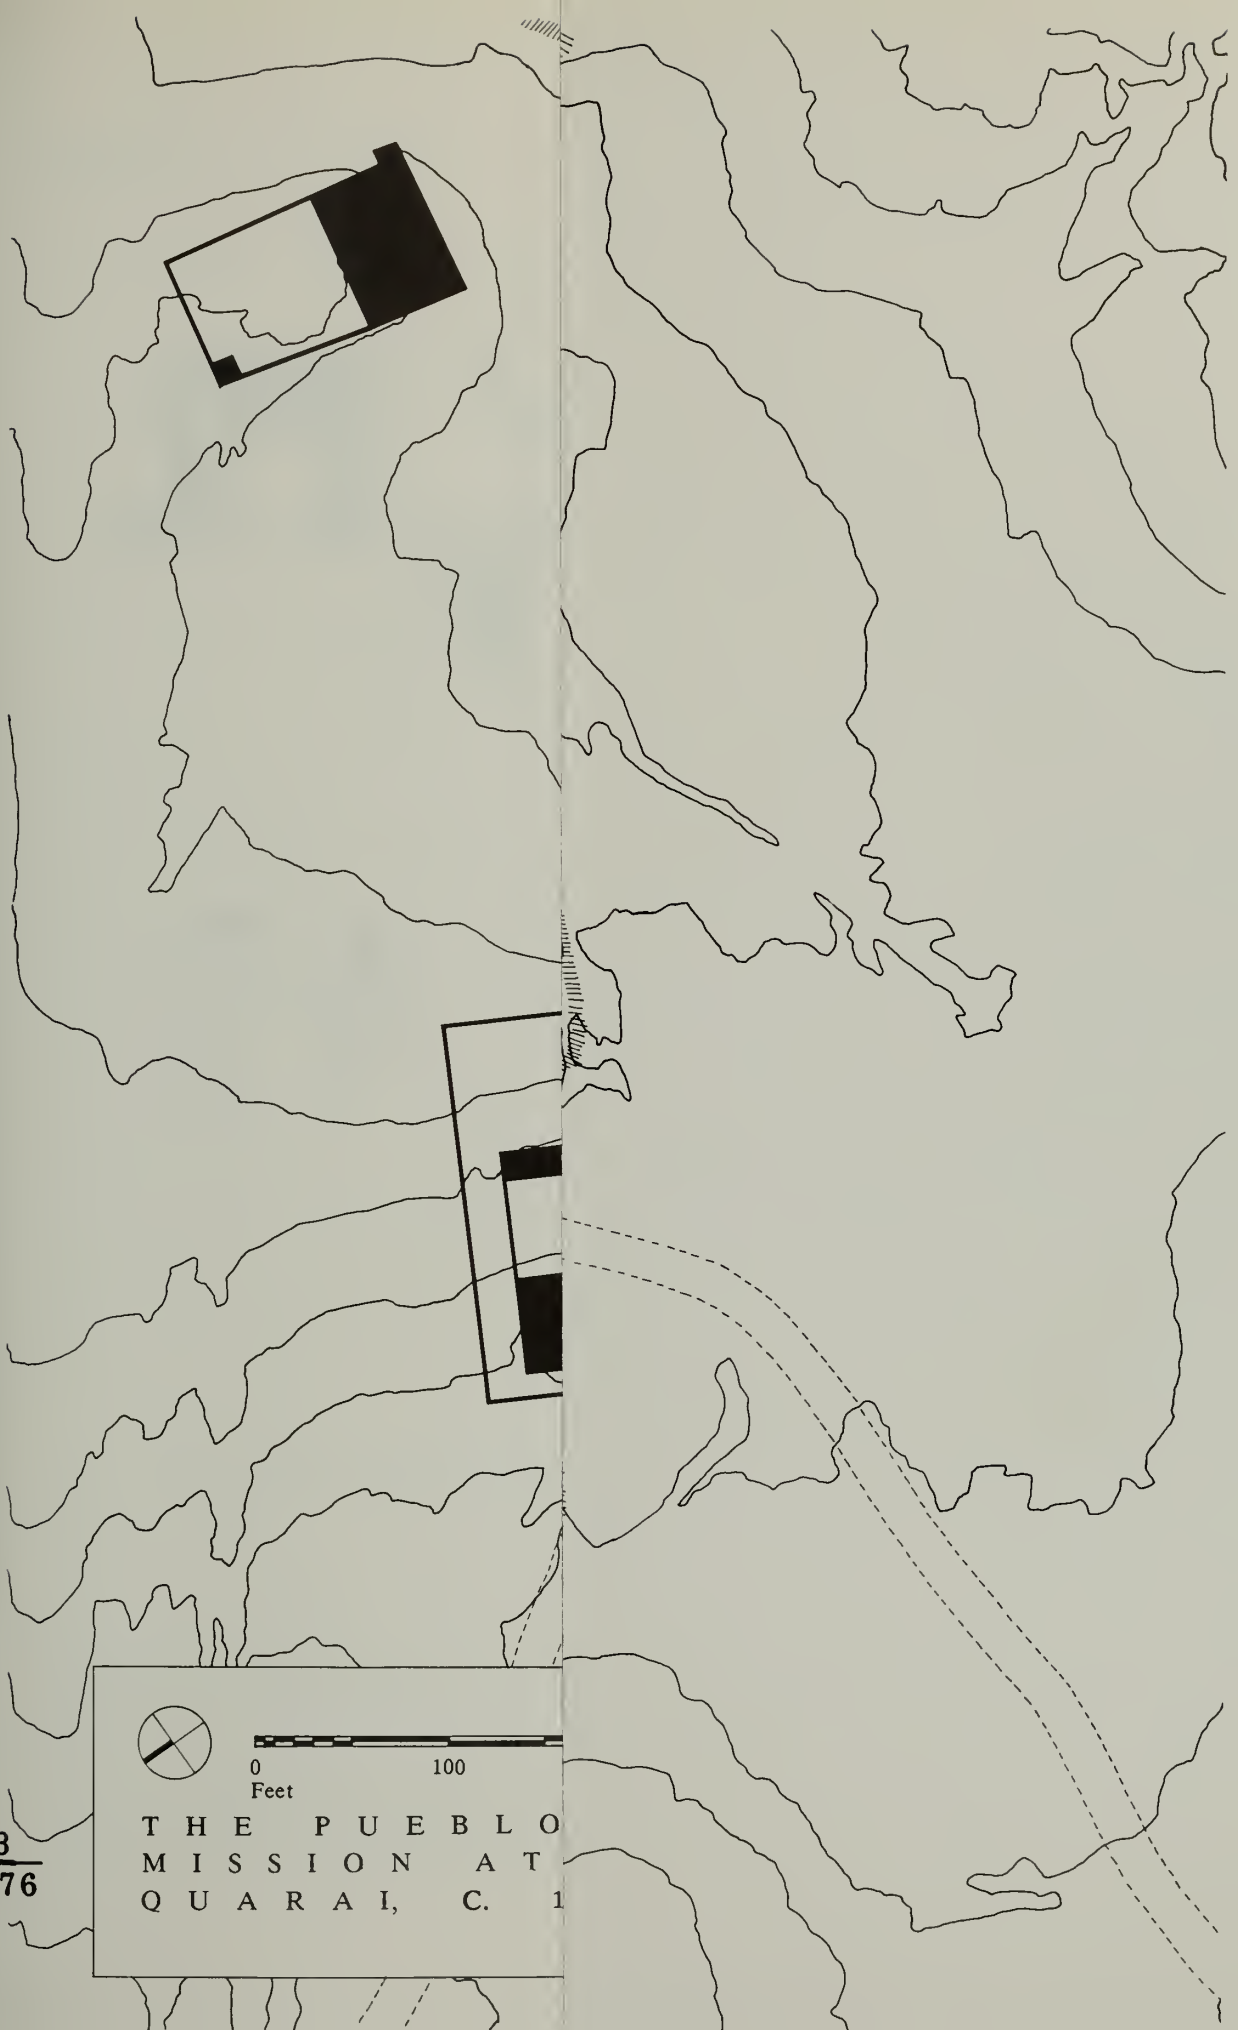
Figure 30. The pueblo of Quarai about 1830. The large structure northeast of the church is the Lucero House, a fortified ranch house or plazuela. The North House, a second plazuela, stands north of the church, and Mound J House is west of the church. The church has not yet been burned and still has most of its roof, except for a section in the center of the transepts that has fallen in. The rooms built onto the old mission storeroom at the southeast corner of the convento can be seen.

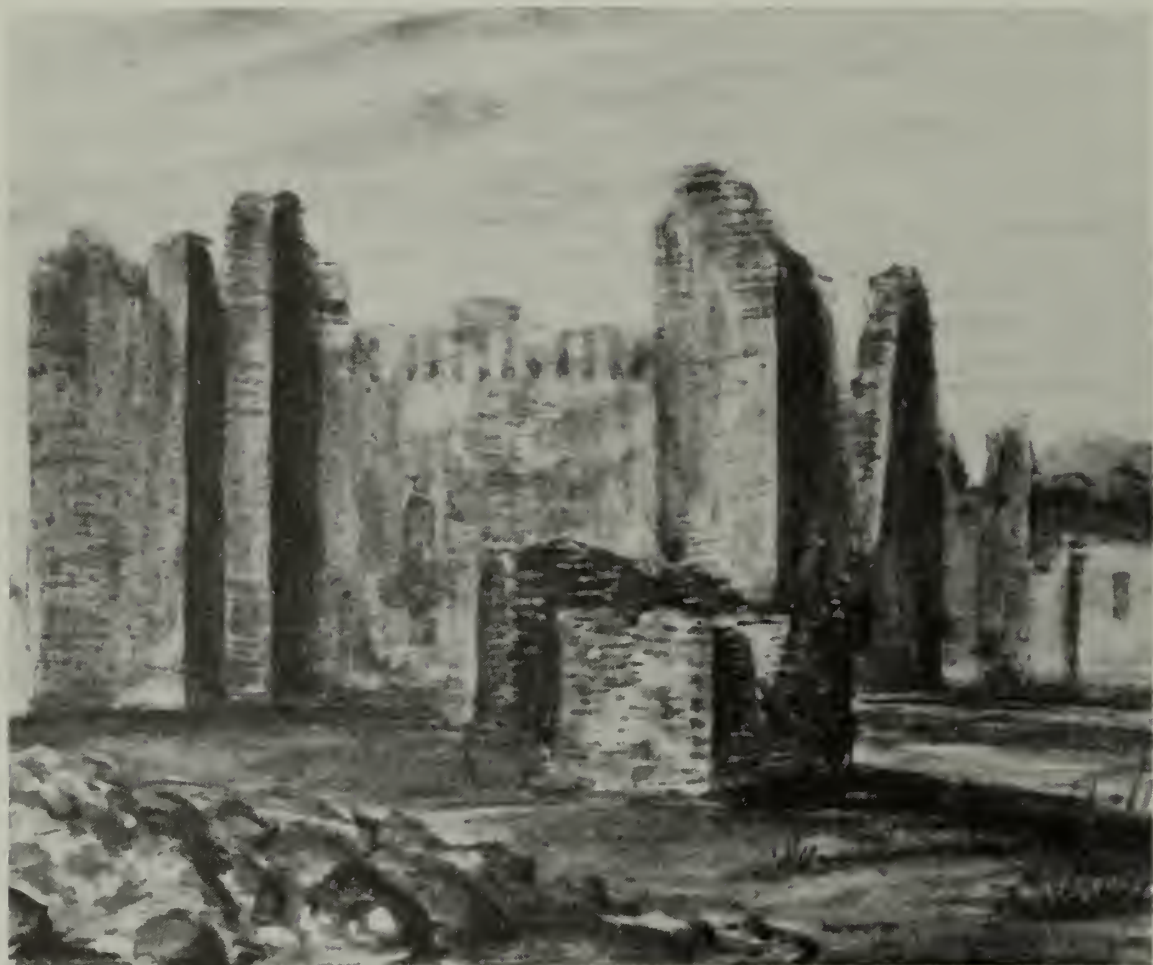
Figure 32. Quarai as painted by James Abert on Wednesday, November 4, 1846. In the foreground is the ruin of Mound J House, with the notch of a collapsed window on the right, or south side. Immediately behind it is the baptistry of the church. Abert indicates that he could see the sockets for the roof vigas of the nave from the outside of the building, meaning that the stonework between the sockets still stood to the height of the tops of the beams in 1846. To the right of the facade of the church, the choir loft stairwell and belltower still stand to the height of the top of the second story window. Just to the right of the belltower rooms is the gap where the *portería* has fallen in, and then the facade of the convento with a window opening, probably into the east hall. The rooms added on the southeast by the Luceros are out of sight to the right.

³⁴See Chapter 8, n. 56, for a detailed discussion of the evidence for the dating of the destruction of the church and other buildings at Quarai. Abert's watercolor of the ruins shows that not only the church but also the baptistry and Mound J House burned out; see figure 32.

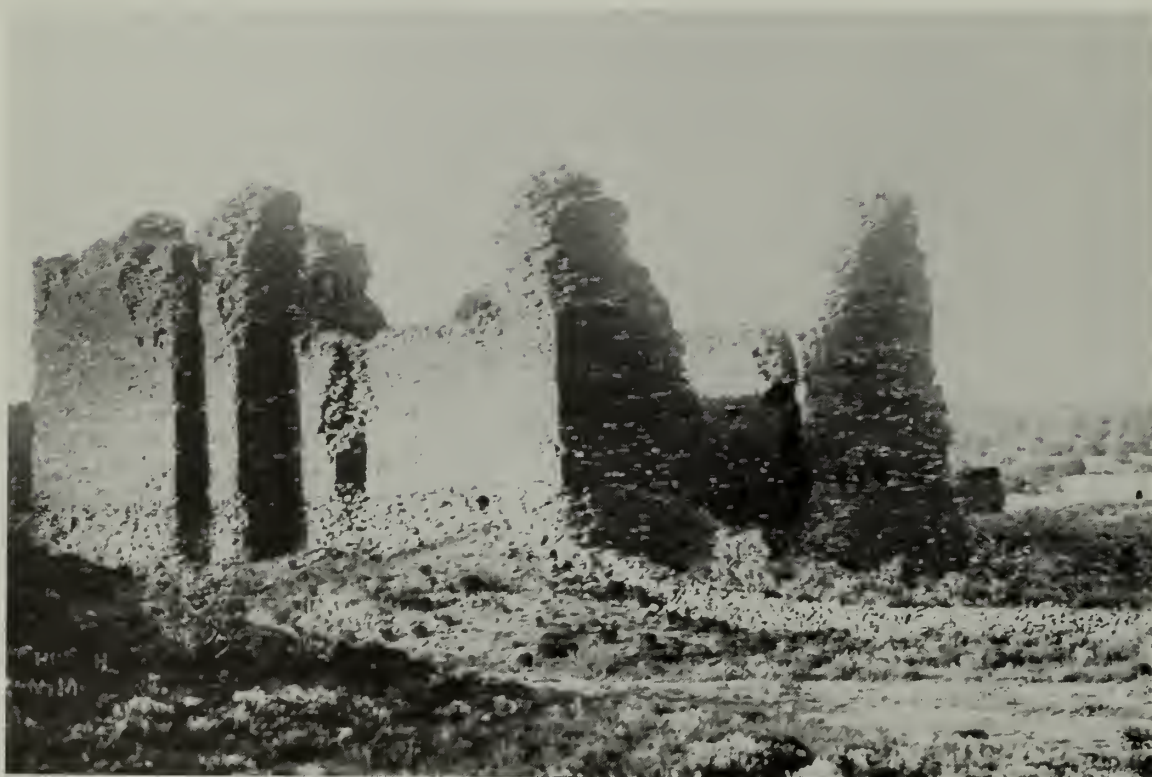
Figure 34. Quarai as photographed by Charles Lummis in 1890. To the right of the church in the distance can be seen the Lucero House, with a covered wagon parked next to it. Below the Lucero house, the ruins of the walls of the south end of the east hall and of room 20 are visible. To the left of the Lucero House, the south wall of room 13 still stands to almost its full height, and three beam sockets can be made out along its top edge. These beams, running north to south, covered the hallway (room 14 from the east hall to the east courtyard. By reconstructing the lines of sight of this scene at Quarai today, it was possible to determine that the top of the wall of room 14 was about 13 feet above the present floor level.

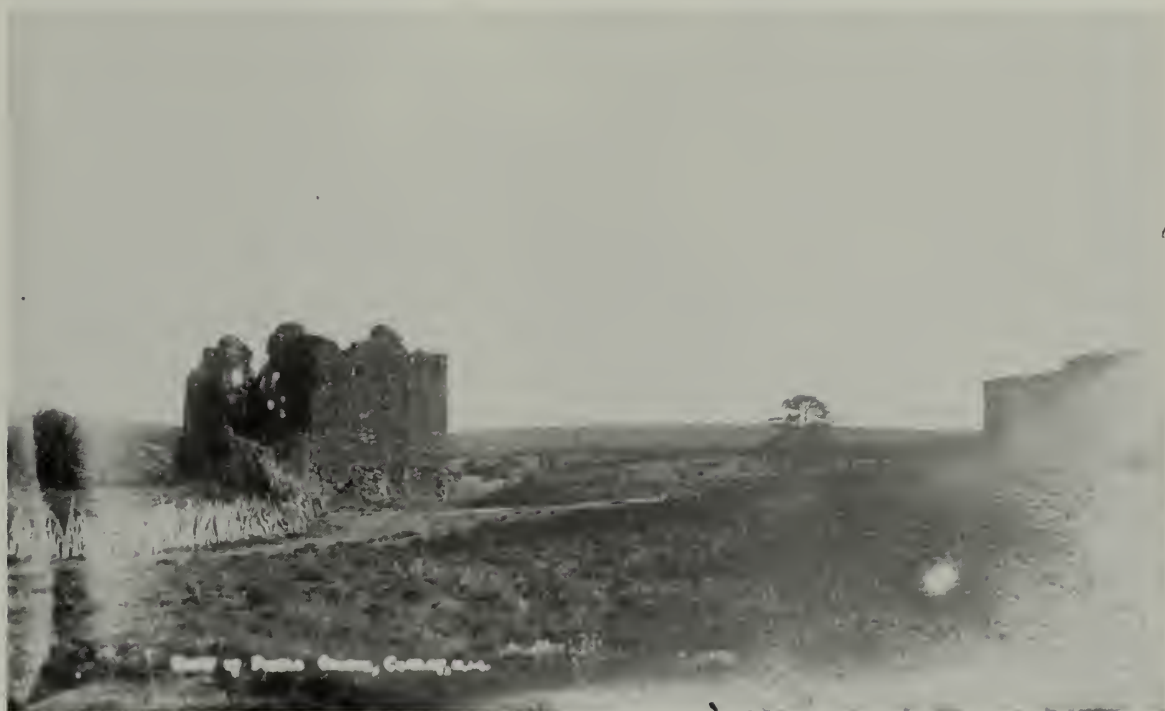
Figure 35. Quarai from the north in 1890. Lummis was the first photographer to record the details of this side of the church. At the right edge of the picture, the North House still stands to its full height. On the left corner of the church the walls of room 6 still stand to the top of the second story, and one roof viga remains in place against the north wall of the east transept. The notch of a window at the second floor level can be seen in the north wall of the room. At the top of the apse, the ventilation opening can clearly be seen, as well as the notch in the top of the wall where the canal that drained the apse roof had penetrated. The road to Abó from Punta de Agua curves around the church with a jacal fence along its east side. The road and fence were both recorded by Bandelier on his plan of the pueblo and mission made from the notes and sketches of his 1882 visit. Courtesy Southwest Museum, # 24828.

³²This description of the North House is based on Charles Lummis photograph SWM # 24828 (1890), figure 34; Quarai Topographic Map, National Park Service, Koogle and Poole Engineering, July 6, 1982; and field measurements by the author.

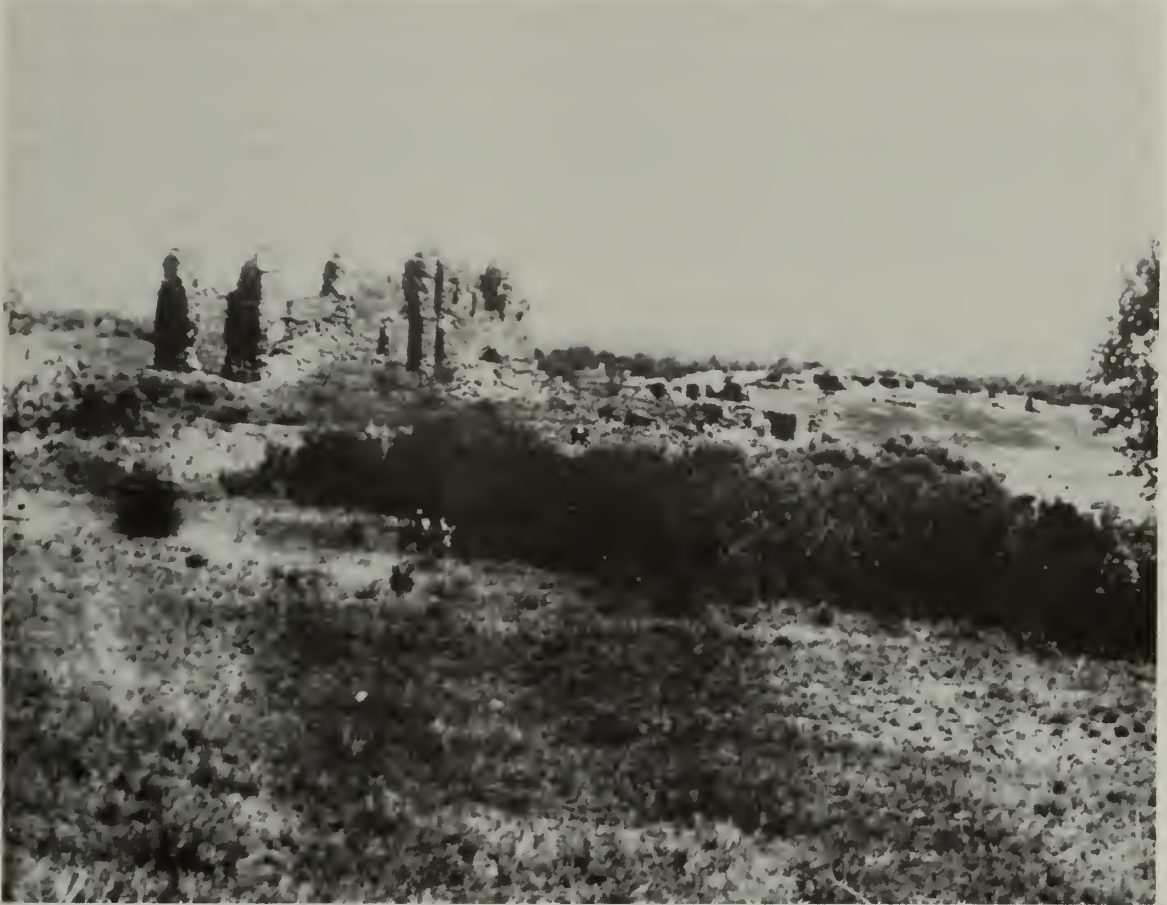
Figure 37. Quarai about 1900 from a photograph found in the files of the National Park Service. This is a print made from a negative made from a slide made of a print of the original negative. With so many generations of duplication, many of the details in the original have been lost, and the source of the photograph is unknown. Careful inspection and comparison with other pictures, however, recovers much useful information from the print. At the right background of the view, the walls of parts of the North House still stand, even though the main east wall visible in the Lummis photograph made in 1890 has fallen. Closer, just above the trees across the center of the photograph, the walls of several rooms of the east courtyard are visible, and just above them the walls in the area of rooms 11, 12, 13, and 29 can be seen. The imprints of most of the walls that adjoined the east wall of the church can be made out by comparison with other photographs. Courtesy National Park Service.

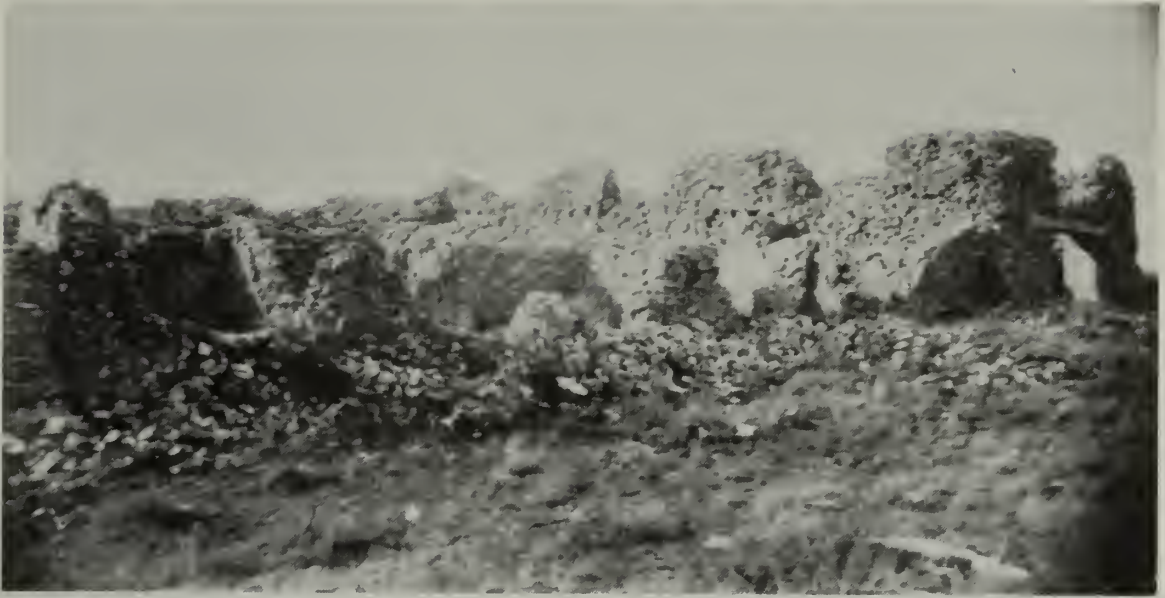
Figure 39. San Buenaventura in 1883, as photographed by Bandelier. The door and window openings high on the wall of the church are still sharp-edged and the tops of the walls flat, straight lines. Biblioteca Apostólica Vaticana, Archivo Fotográfico, #14116-49, courtesy Charles Lang.
